Case Study

SOLVING CLOGGING FROM
SEEDS & SKINS

TOMATO PROCESSING TANK WASHING SOLUTION

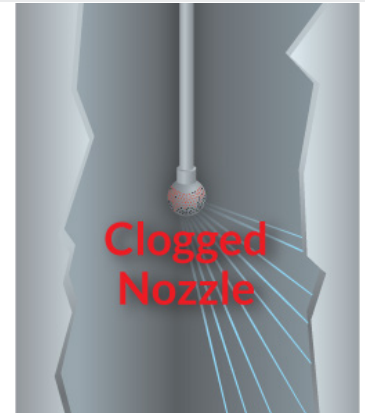
After installing six total competitor disc cleaning nozzles into two tanks, 100" diameter by 80" high, they observed clogging caused by seeds and skins that were in their recirculated water system. Displeased with constant blockage and too much time wasted on nozzle maintenance, they worked with BETE Applications Engineers to solve the problem and improve efficiencies in keeping their tomato processing tanks clean.

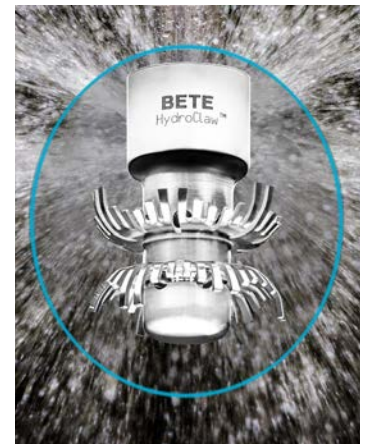
After assessing the dimensions of their vessels, BETE engineers recommended six HydroClaw® 100 nozzles, three for each tank. The ¼" free passage makes them an ideal solution for flushing through tomato seeds and skins with the recirculated water.

The low-maintenance HydroClaw® self-flushes as it cleans tanks without any rotating parts or gears to jam up.

- Nozzle designed to let particulates and sediment flow through with no clogging
- Clog resistance and low maintenance = reduced downtime and more economical water usage
- 316L stainless steel construction means it is perfect for clean-in-place (CIP) and food grade applications
- Complete 360-degree coverage
